**Pre-Demolition  
Asbestos Building Material Inspection**

**134 Walters Way  
Tarentum, PA 15084**

**Tarentum Borough  
318 E 2<sup>nd</sup> Avenue  
Tarentum, PA 15084**

**Corwin Inspections LLC  
116 Eileen Drive  
Pittsburgh, Pennsylvania 15214**

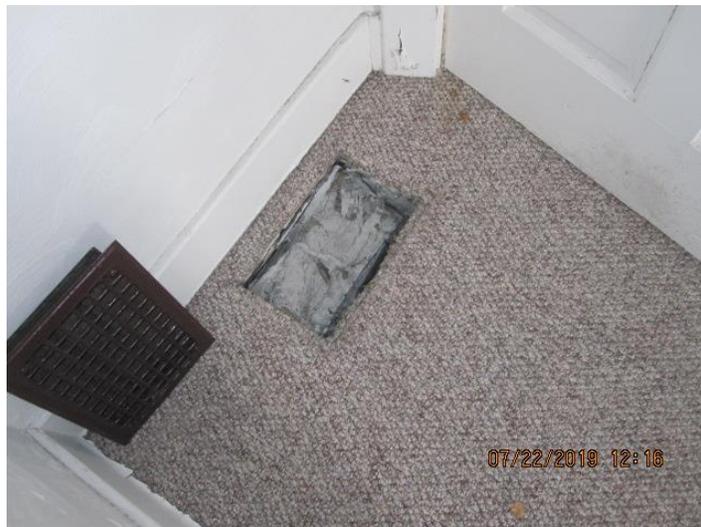
**Duct Tape/Wrap** – Asbestos containing duct wrap/tape was observed on the ductwork within the walls of the house. This material extends through the walls covering the ducts. The observed asbestos containing duct wrap was in good condition and considered to be RACM. The total estimated quantity of asbestos containing duct wrap was **125 sq. ft.**

HA #	Sample #	Material	Location(s)	Condition/Category	Estimated Quantity
3	WL-3	Duct Wrap/Tape	Ductwork, within walls	Slightly Damaged RACM	125 sq. ft.
<b>Total Duct Wrap/Tape</b>					<b>125 sq. ft.</b>

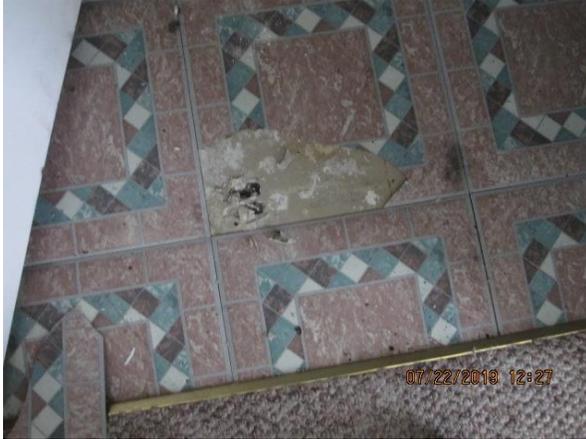
**Floor Tile and Mastic** - The 9" white floor tile and black mastic in the 2<sup>nd</sup> floor bathroom were found to be asbestos containing materials. This flooring layer was covered with a non-asbestos containing layer of 12" floor tiles, these tiles were adhered directly to the asbestos containing layer, effectivity making a double layer of floor tile. The total estimated quantity of asbestos containing floor tile and mastic was **50 sq. ft.**

HA #	Sample #	Material	Location(s)	Condition/Category	Estimated Quantity
8	WL-12	White Linoleum	1 <sup>st</sup> Floor, Kitchen, Top Layer	Good NF1	50 sq. ft.
<b>Total Flooring Materials</b>					<b>50 sq. ft.</b>

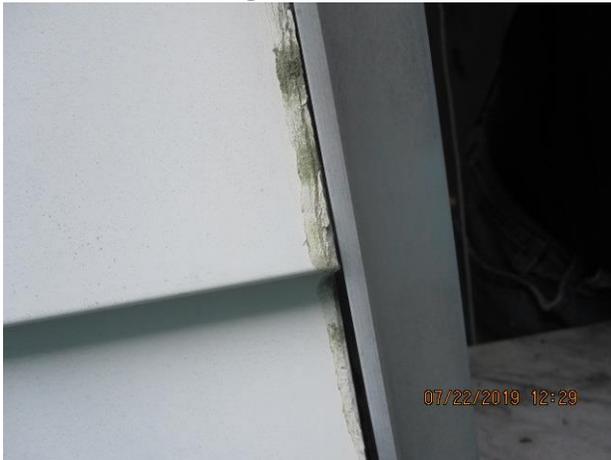
**Exterior Caulkings** – The exterior caulking around the perimeter of the doors and windows was found to be an asbestos containing material. There were approximately 9 window units and 2 doors with asbestos caulking around the perimeter. There was approximately **163 linear feet** of asbestos containing exterior window and door caulking.

HA #	Sample #	Material	Location(s)	Condition/Category	Estimated Quantity
10	WL-14	Window/Door Caulking	Exterior Windows and Doors	Good NF 1	163 Lin. ft.
<b>Total Exterior Caulking</b>					<b>163 Lin. ft.</b>
