**Pre-Demolition
Asbestos Building Material Inspection**

**209/211 Conroy Avenue
Tarentum, PA 15084**

**Tarentum Borough
318 E 2nd Avenue
Tarentum, PA 15084**

**Corwin Inspections LLC
116 Eileen Drive
Pittsburgh, Pennsylvania 15214**

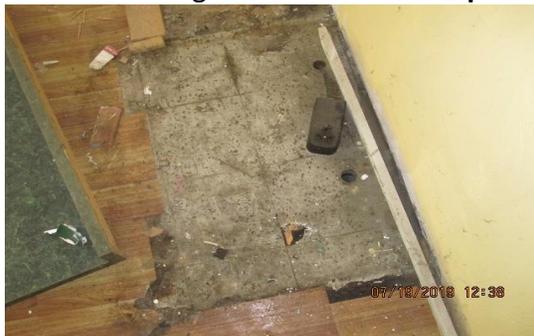
Floor Tile- The 9" grey floor tile in the front room (kitchen) in both the 209 and 211 sides were found to be asbestos containing materials. The tile in the 209 side was beneath a layer of non-asbestos containing woodgrain floor tile, which was adhered directly to the asbestos containing tile. This effectively made a double layer of floor tile (285 sq. ft.) The tile in 211 side was residual remnants sporadically covering areas of the floor (55 sq. ft.). None of the mastics associated with these tiles were found to contain asbestos. The total estimated quantity of asbestos containing floor tile was **340 sq. ft.**

Double layer of tile, 209 side

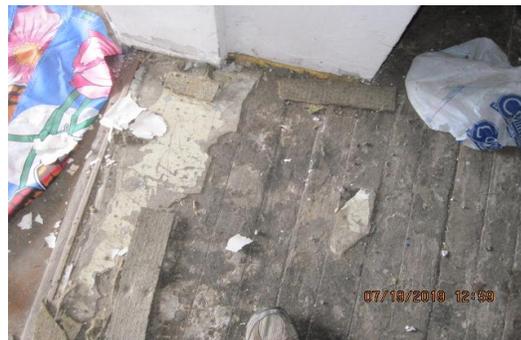
Remnants of asbestos tile, 211 side

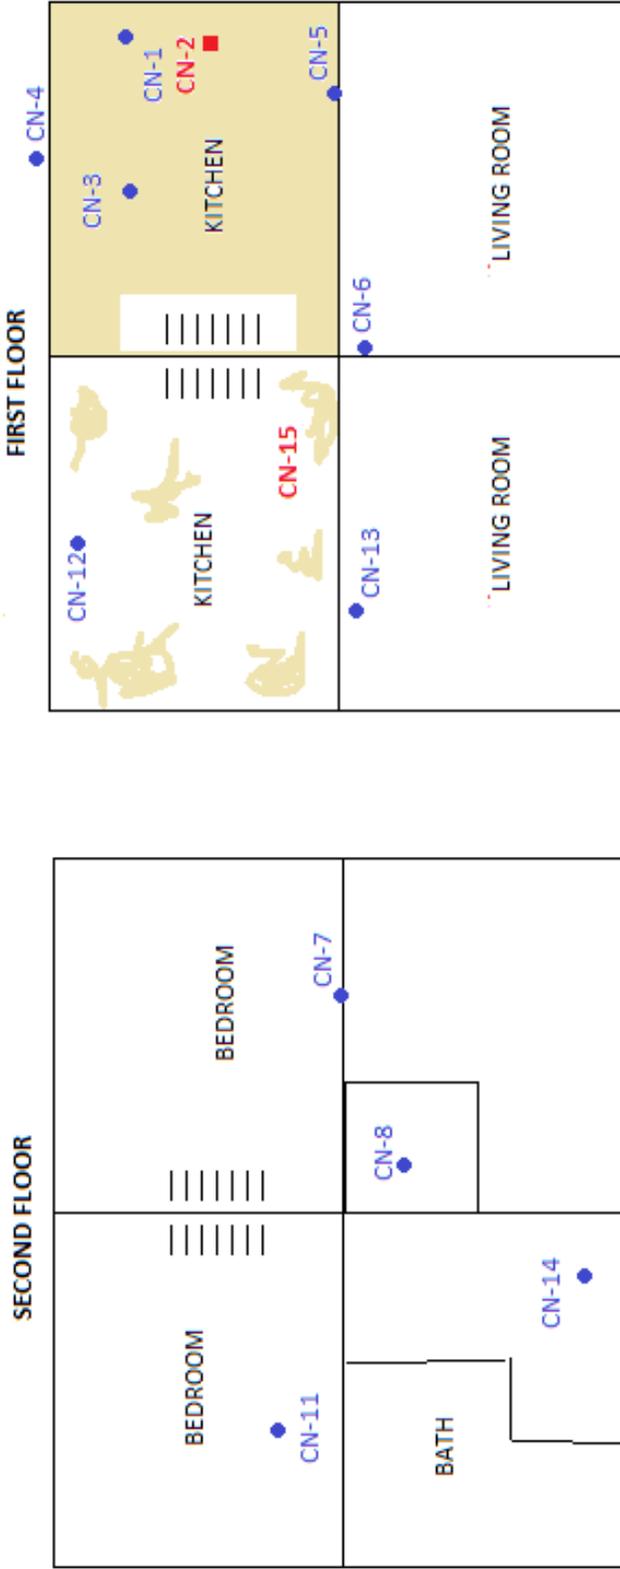
**Asbestos Survey Floor Plan
209-211 Conroy Avenue
Tarentum, PA 15084**

Sample locations and ACM materials locations approximate.
