**PRE-DEMOLITION ASBESTOS BUILDING
MATERIALS INSPECTION OF
1320 LOCUST STREET
TARENTUM, PA 15084**

Tarentum Borough
318 E 2nd Avenue
Tarentum, PA 15084

Corwin Inspections LLC
222 Haymont Drive
Gibsonia, PA 15044

At the request of Michael L. Nestico, Borough Manager, Corwin Inspections LLC conducted a pre-demolition asbestos building materials inspection of 1320 Locust Street, Tarentum, PA 15084. The inspection was conducted on October 14, 2020 and was performed by Mr. Steven M. Corwin, a Certified Pennsylvania Building Inspector: 029238.

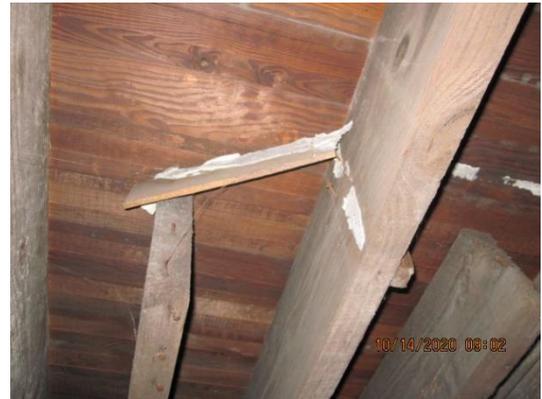
Duct Wrap – Asbestos containing duct tape was observed on the joists in the basement. This material appeared to have once sealed ductwork to the wooden joists. The metal ductwork was no longer present and the remnants of the duct tape remained. The duct tape was in damaged condition and considered to be RACM. The total estimated quantity of asbestos containing duct wrap was **3 sq. ft.**

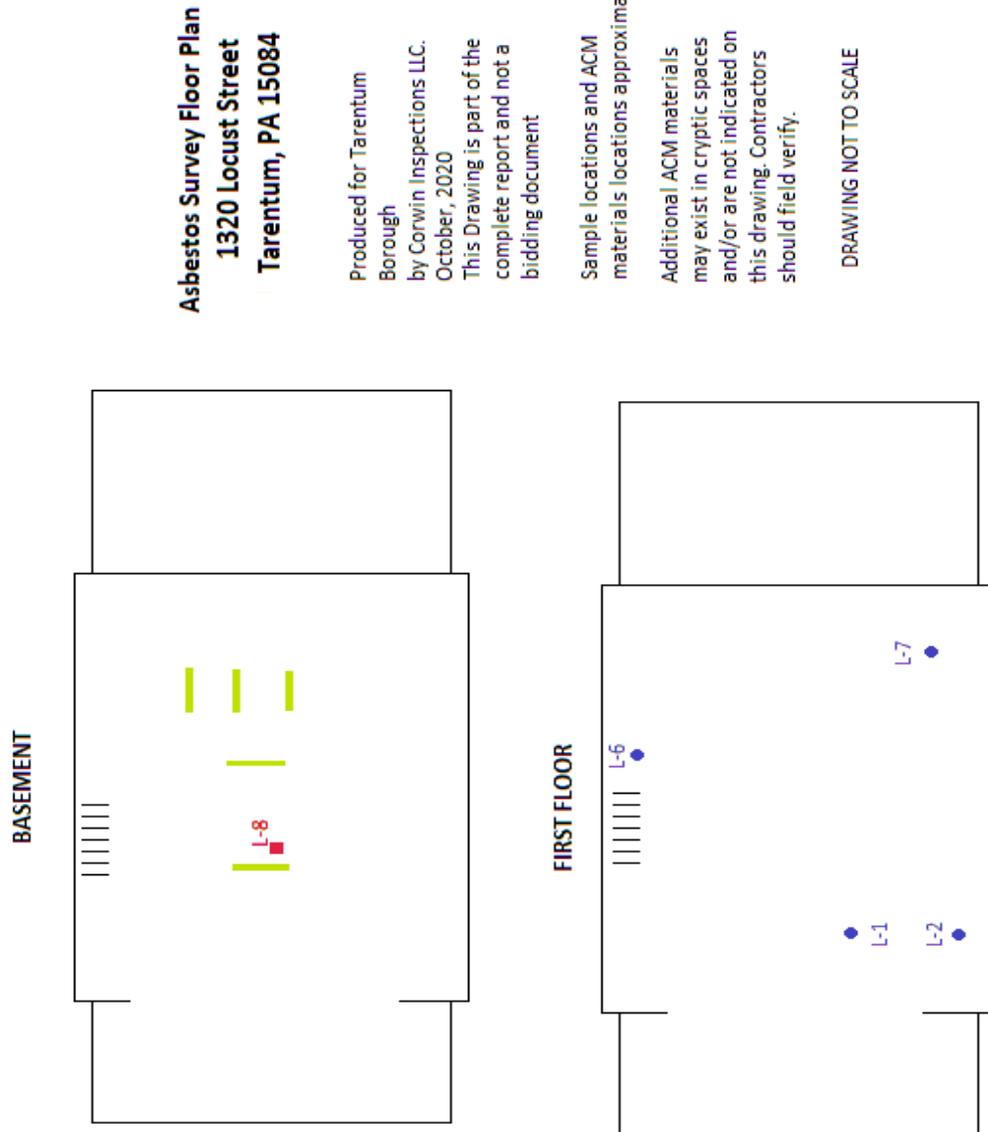
Sample Location Floor Plans

Bulk Sample and Analysis			
Sample #	Description	Location	Asbestos %
L-1	9" White Floor Tile and Mastic	1 st Floor, Main Room	ND
L-2	9" White Floor tile and Mastic	1 st Floor, Main Room	ND
L-3	Roofing	Roof	ND
L-4	Roofing	Roof	ND
L-5	Roofing	Roof	ND
L-6	Drywall and Compound	1 st Floor, Main Room	ND
L-7	1' X 1' Ceiling Tile	1 st Floor, Main Room	ND
L-8	Duct Tape	Basement	65%
