**PRE-DEMOLITION ASBESTOS BUILDING
MATERIALS INSPECTION OF
212 BRIDGE STREET
TARENTUM, PA 15084**

**Asbestos Survey Floor Plan
212 Bridge Street
Tarentum, PA 15084**

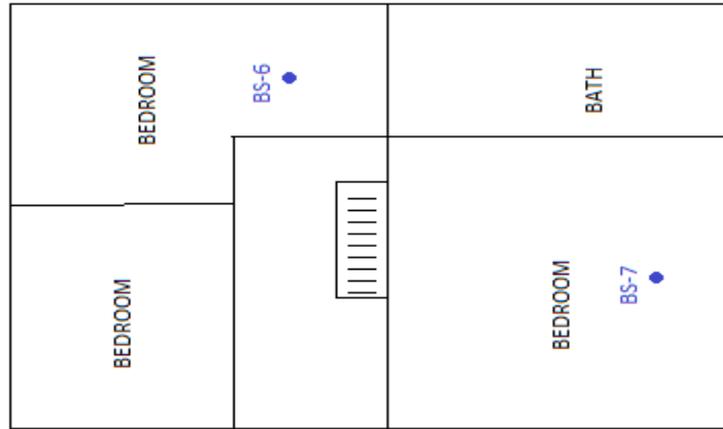
SECOND FLOOR

Sample locations and ACM materials locations approximate.
