**Pre-Demolition
Asbestos Building Material Inspection**

**339 W 11th Avenue
Tarentum, PA 15084**

**Tarentum Borough
318 E 2nd Avenue
Tarentum, PA 15084**

**Corwin Inspections LLC
116 Eileen Drive
Pittsburgh, Pennsylvania 15214**

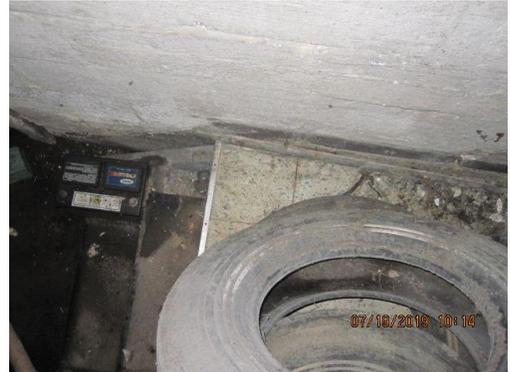
Floor Tile – The floor tile on the basement stair landing was found to be an asbestos containing material. The mastic associated with these tiles was found to be non-asbestos containing. The total estimated quantity of asbestos containing floor tile was **40 sq. ft.**

HA #	Sample #	Material	Location(s)	Condition/ Category	Estimated Quantity
2	WE-4	9" Floor Tile	Basement Stairs, Landing	Good NF1	40 sq. ft.
Total Flooring Materials					40 sq. ft.

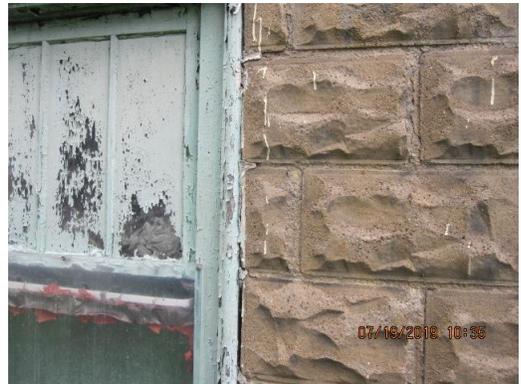
Exterior Caulkings – The exterior caulking around the perimeter of the doors and windows was found to be an asbestos containing material. There were approximately 20 window units and 4 doors with asbestos caulking around the perimeter. There was approximately **320 linear feet** of asbestos containing exterior window and door caulking.

HA #	Sample #	Material	Location(s)	Condition/ Category	Estimated Quantity
4	WE-6	Exterior Window/Door Caulking	Exterior Perimeter of Windows and Doors	Good NF 1	320 ln. ft.
Total Caulking Materials					320 ln. ft.
