**Pre-Demolition  
Asbestos Building Material Inspection**

**134 Walters Way  
Tarentum, PA 15084**

**Tarentum Borough  
318 E 2<sup>nd</sup> Avenue  
Tarentum, PA 15084**

**Corwin Inspections LLC  
116 Eileen Drive  
Pittsburgh, Pennsylvania 15214**

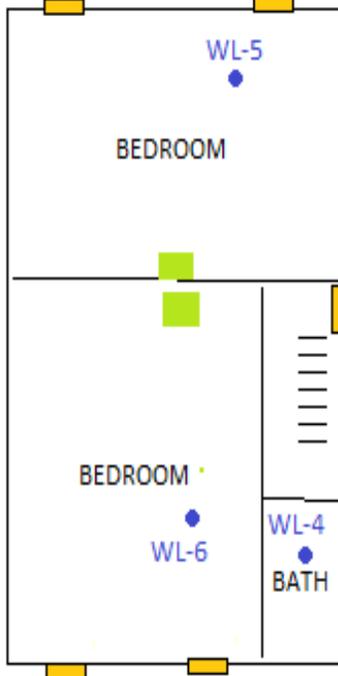
SECOND FLOOR

**Floor Tile and Mastic** - The 9" white floor tile and black mastic in the 2<sup>nd</sup> floor bathroom were found to be asbestos containing materials. This flooring layer was covered with a non-asbestos containing layer of 12" floor tiles, these tiles were adhered directly to the asbestos containing layer, effectivity making a double layer of floor tile. The total estimated quantity of asbestos containing floor tile and mastic was **50 sq. ft.**
