Outreach Assistance Program  
Asset Management Plan Report

**Tarentum Borough Water Department**  
Public Water System ID # 5020055

Report Date: May 2023

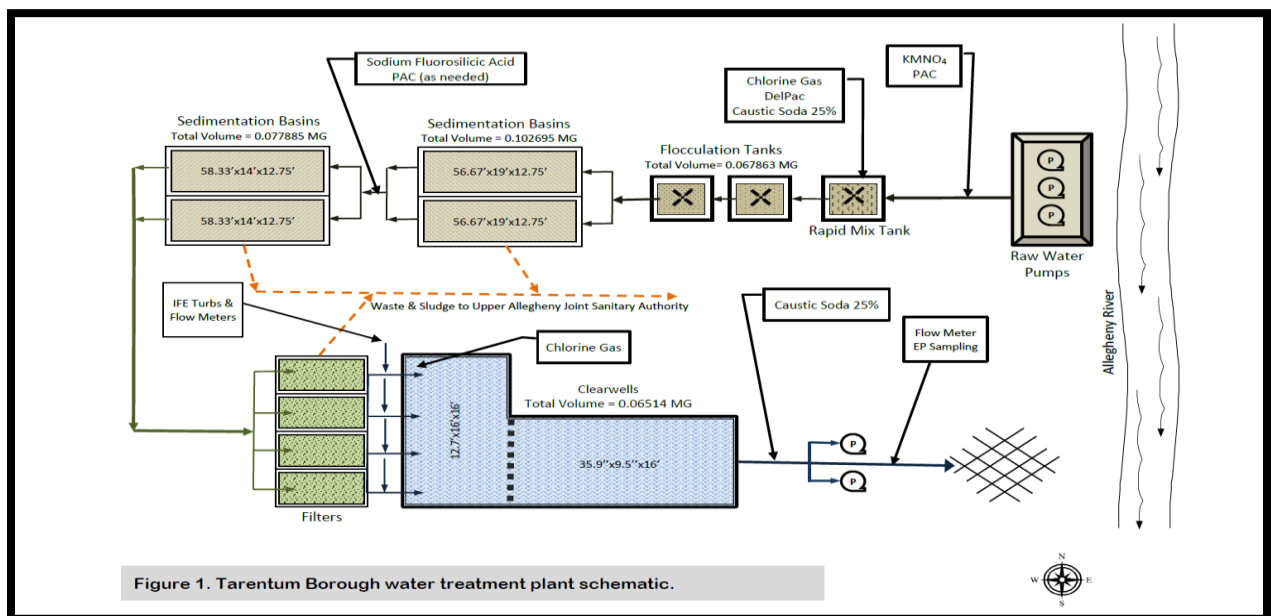
The water treatment plant (WTP) obtains raw water from the Allegheny River. Treatment at the WTP includes powder active carbon (taste and odor control), potassium permanganate (oxidant), gaseous chlorine (oxidant and disinfectant), polyaluminum chloride (Delpac 2020) (coagulant), caustic soda (25% sodium hydroxide) (pH adjustment) and sodium fluorosilicic acid (fluoridation). System storage consists of three standpipes, located at one site, total system storage 1.25 MG, tanks operate with common inlet and outlet piping. System maintains an estimated 14.3 miles of distribution piping.

Figure 1. Tarentum Borough water treatment plant schematic.

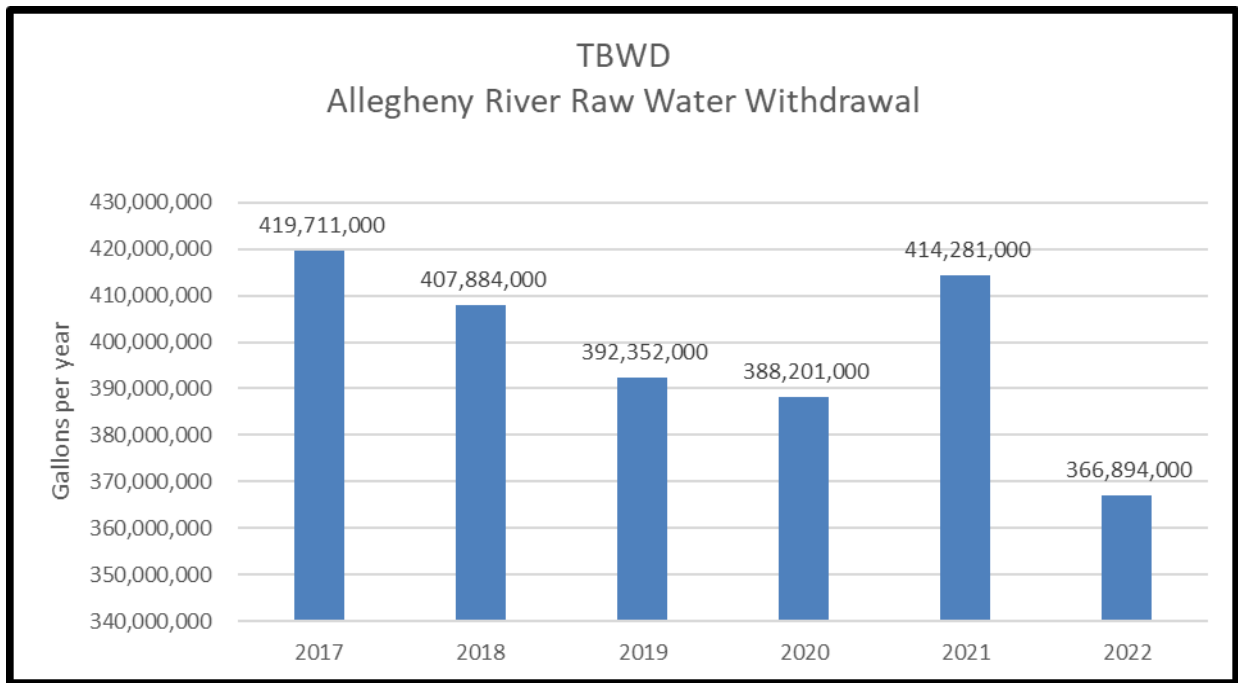
- 4.3.1. **Source ID 001 – Allegheny River** – Order of Confirmation issued in 1939, 2.0 MGD permitted withdrawal of 2.0 MGD or 1,389 gpm – Allegheny River 2021 Chapter 110 Water Withdrawal = 441.281 MG/year = 1.21 MGD (840 gpm) – utilized 365 days in 2021

- 4.3.1.1. TBWD maintains one intake on the Allegheny River, the intake is dredged every 3 to 5 years and intake screen is inspected at that time.
  - 4.3.1.2. In-service transmission Line -3,800' of 12" cast iron; installed in 1955; life expectancy is 80 years; replacement cost per foot is based on industry estimate shown on tab 11 of asset management spreadsheet. Utilized replacement cost for ductile iron pipe.
